Fig. 280. VIEW OF THE BIG HOUSE.

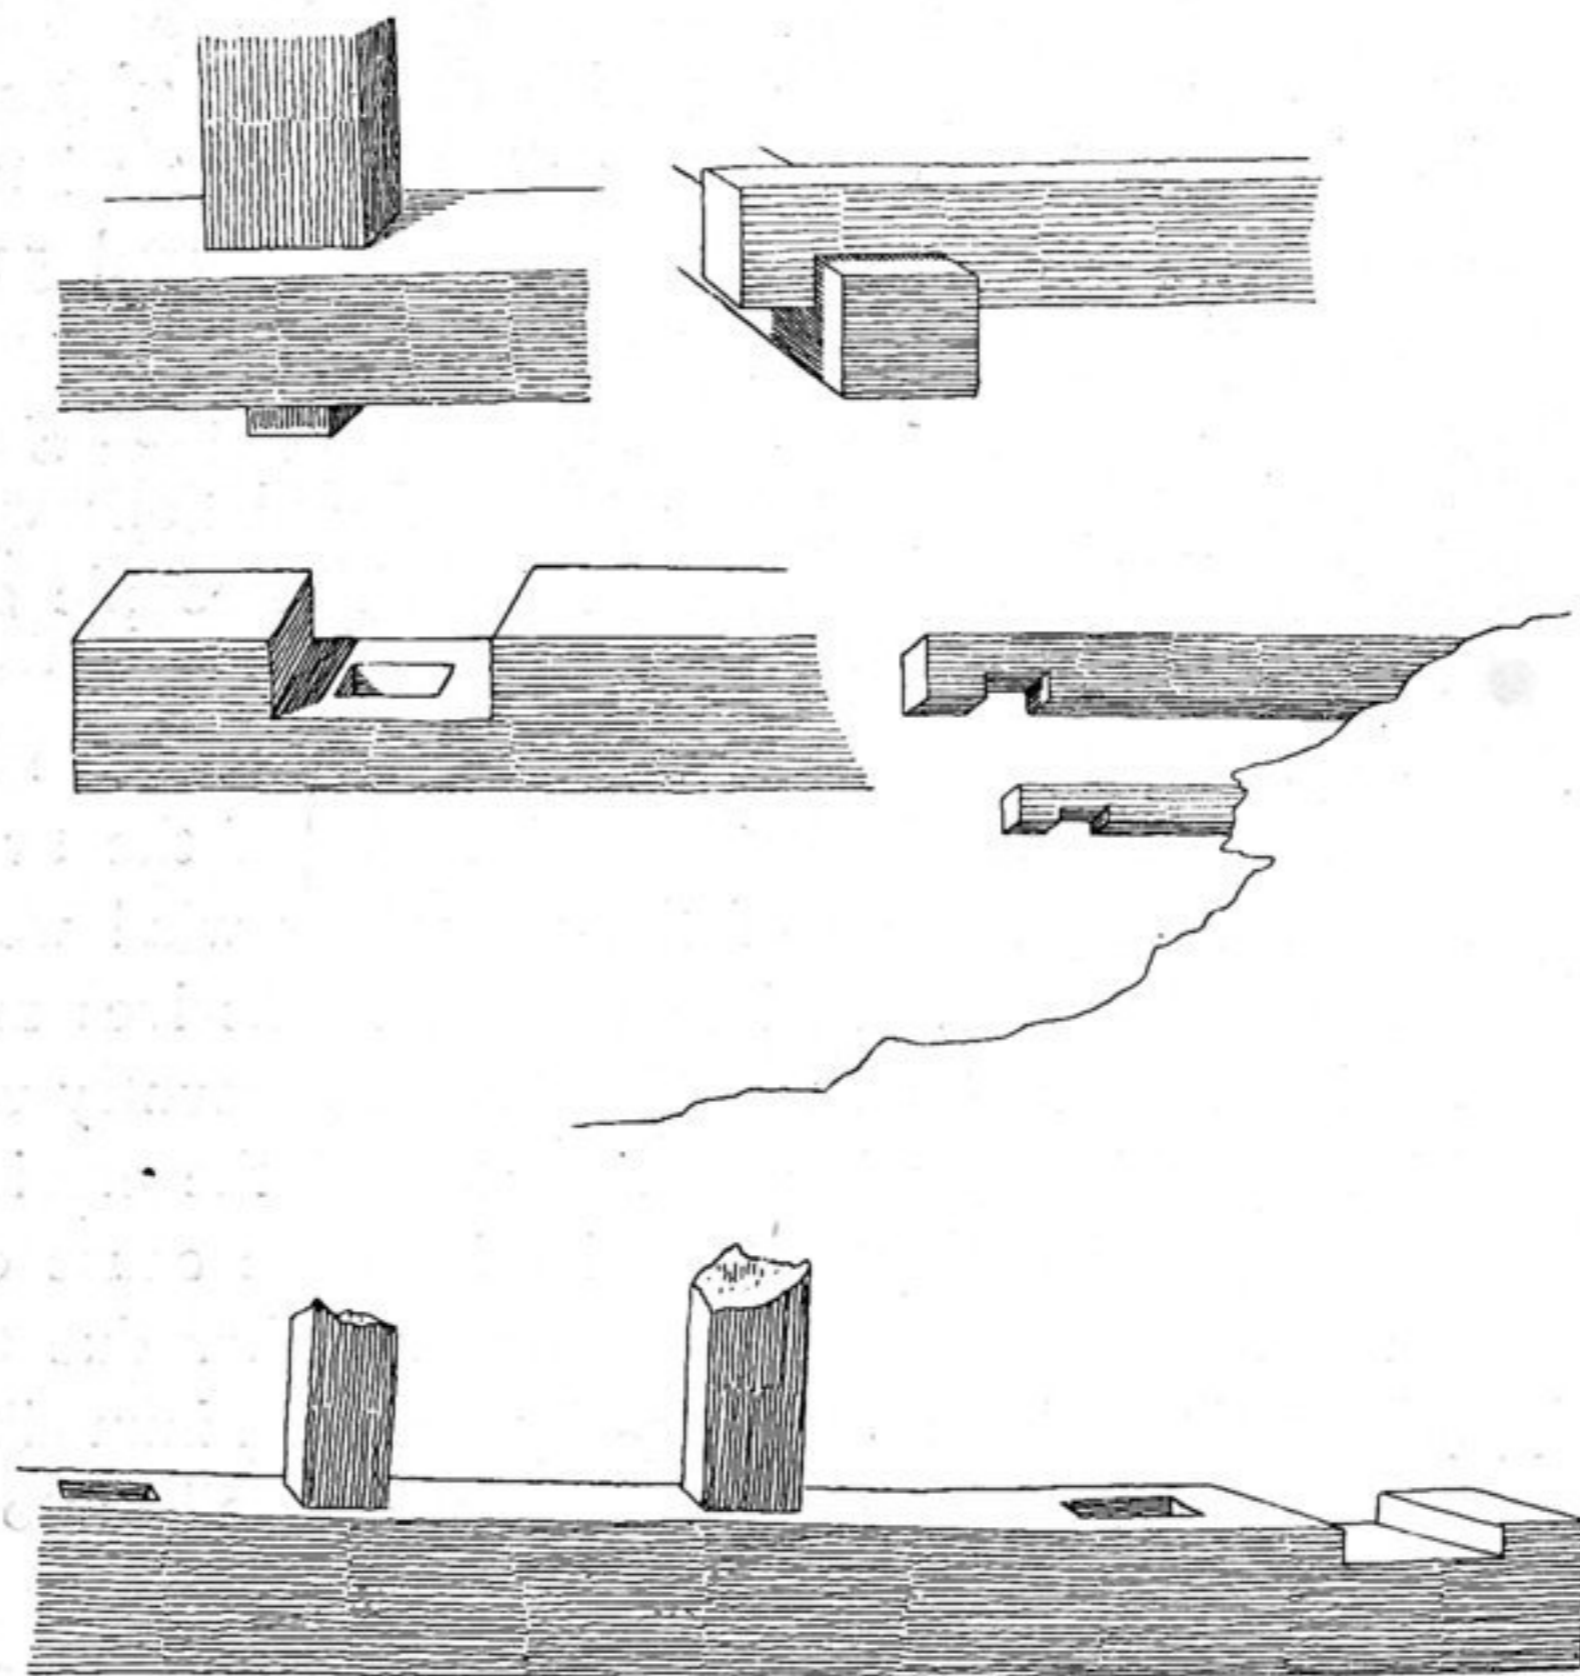
Fig. 281.

fectly level and horizontal ground. The two mounds and the hollow between them, as also the depressions on their outer sides, all came into existence at a subsequent date. The mortice cut (see fig. 281) on the under side of the extreme end of the cross foundation-beam proves that the longer side-beam was placed under the cross-beams, which again were likewise fitted into mortices cut in the long beam. This latter now lies in a condition such as to be hardly recognisable at the eastern base of the platform, where it has fallen since the underlying ground was excavated and blown away. At the present time the ends of the cross-beams project about 3 m. beyond the platform, and the wind is still continuing its undermining work. But the timber that still remains on the top of the platform, equally whether it belonged to the foundation-beams or to portions of the walls and roof which have fallen in, affords an efficient protection to the platform, and sufficiently neutralises the effects of the wind's erosion. It is on these platforms alone, then, that the surface remains at the same level that it stood at when these houses were built. Another proof that nothing but the wind can have carved out these platforms is to be
