84. NORTH ROOMS OF RUIN N. XIII., NIYA SITE, AFTER EXCAVATION.

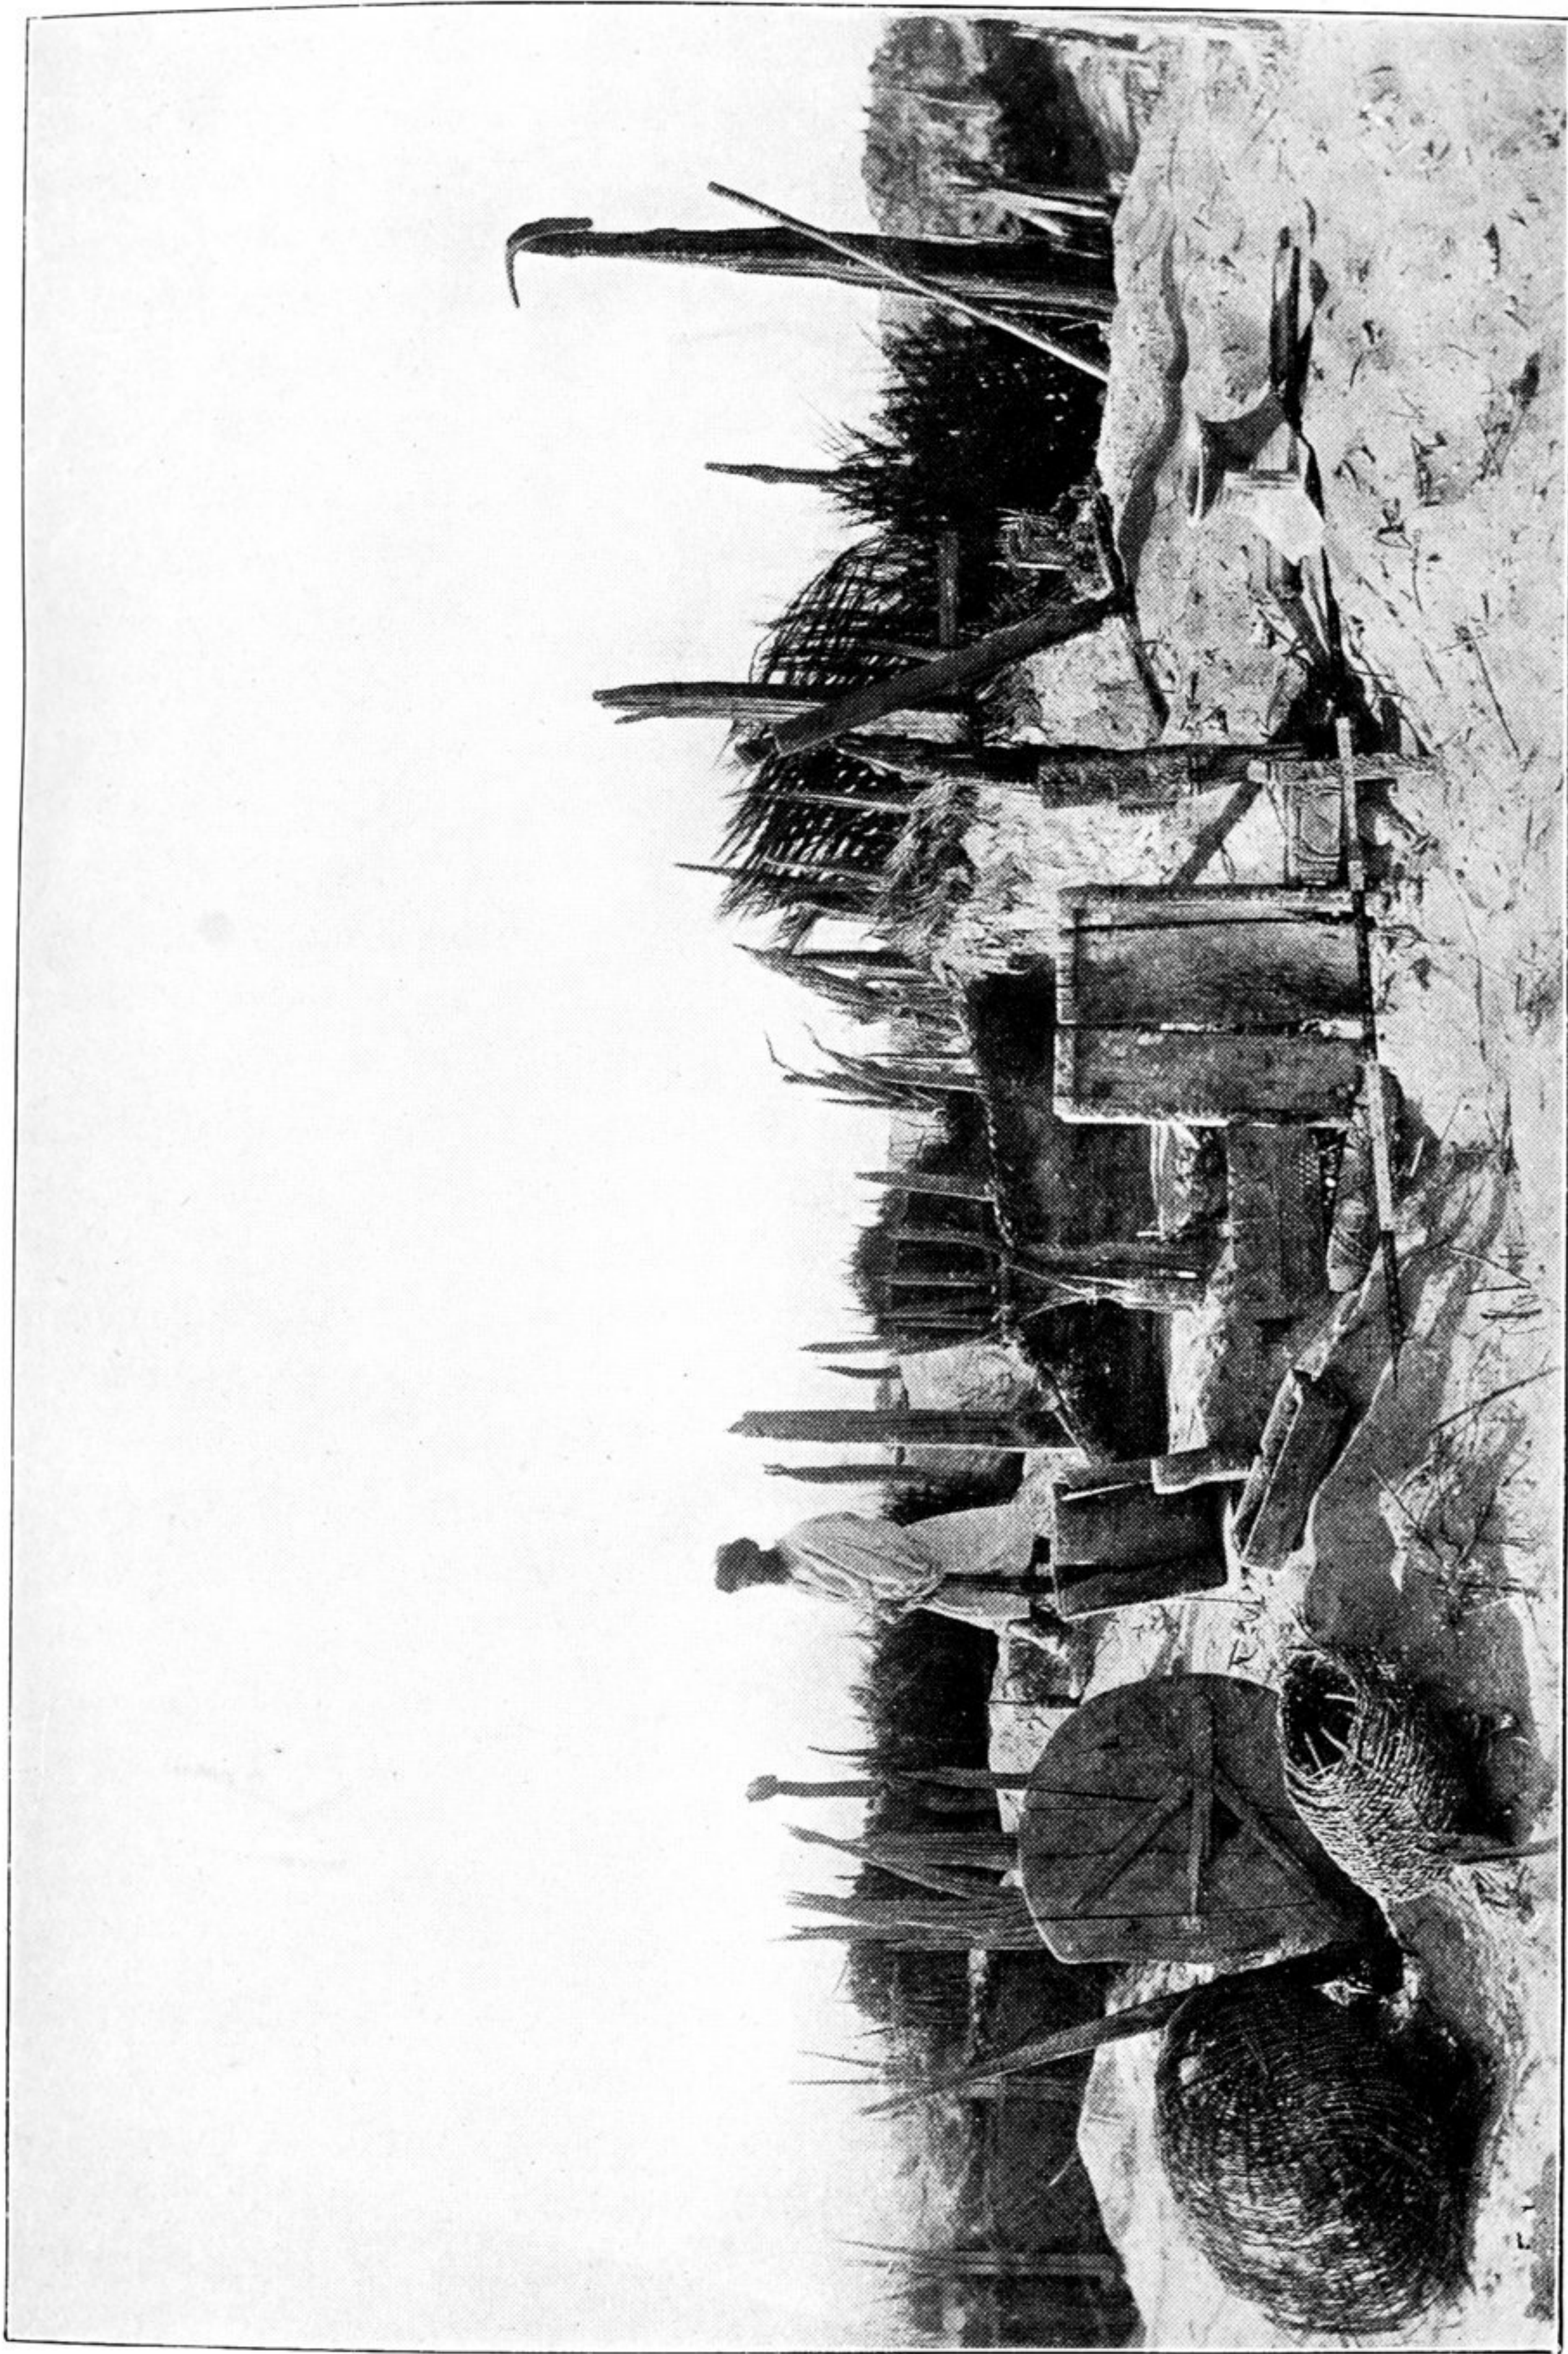
In foreground remains of ancient household furniture and implements. The photograph shows the construction of wall with timber framework and wattled matting.
